Manhole Inspection Summary

Manhole # S71E1_010MH

Record Plat: **71E1** Node: **010** Status: **Found**

Location Address: **6531 Parnell Ave.**

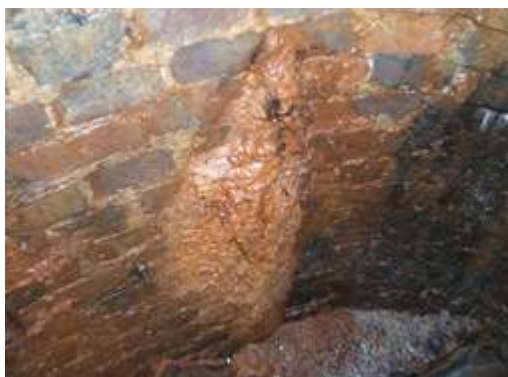
Defect 3

Infiltration

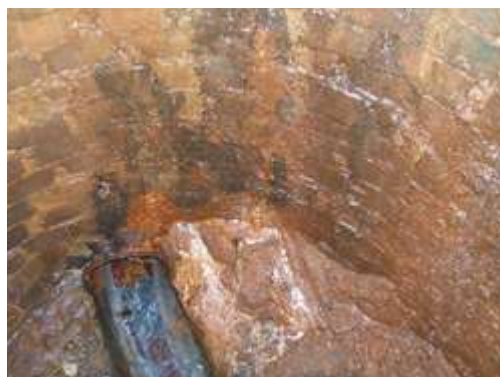
Defect 2

Infiltration debris on bench.

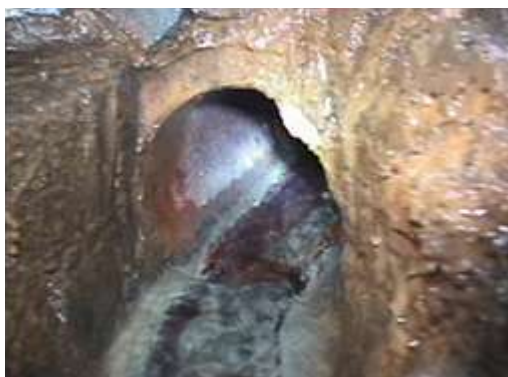
Defect 1

[dae] deposit attached encrustation
12oclock outgoing connection from the 12
to the 5. Also running onto bench.

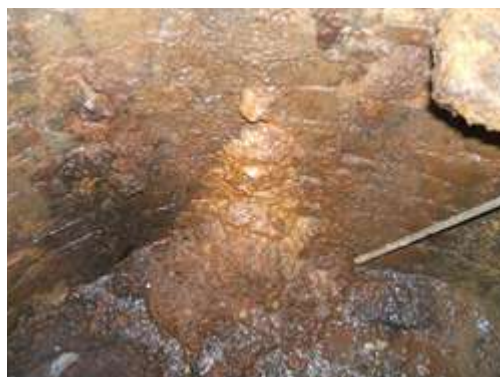
Defect 4

Infiltration

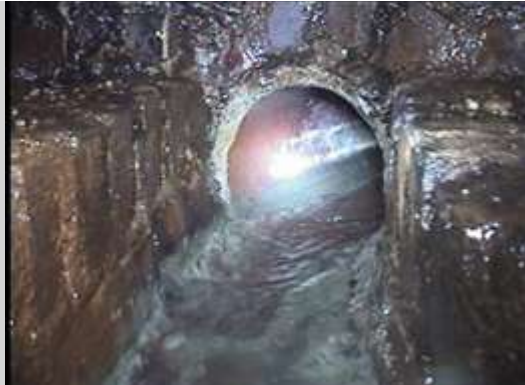
12 O'Clock Outflow

Pipe Height: **8.4** (in.) Rod and Bar (Angled)
Pipe Material: **Clay** ☐ Pipe Lined
Invert Depth: **11.29** (ft.) Flow Characteristics: **Fast**
Deposits: ☐ None ☐ Mud ☒ **Sludge** ☐ Debris ☐ Grease
Silt Depth: **0.5** (in.) Deposits Extent: **Light**
Infiltration: **None** Pipe Seal Cond: **Sound**

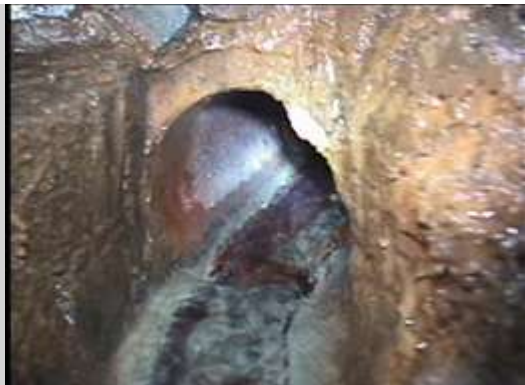
6 O'Clock Inflow

Pipe Height: **8.4** (in.) Rod and Bar (Angled)
Pipe Material: **Clay** ☐ Pipe Lined
Invert Depth: **11.33** (ft.) Flow Characteristics: **Fast**
Deposits: ☐ None ☐ Mud ☒ **Sludge** ☐ Debris ☒ Grease
Silt Depth: **0.25** (in.) Deposits Extent: **Light**
Infiltration: **None** Pipe Seal Cond: **Sound**
